AN EVALUATION OF VAPOR-DEPOSITED
TUNGSTEN TUBING

TOPICAL REPORT
AN EVALUATION OF VAPOR-DEPOSITED
TUNGSTEN TUBING

Sponsored by
NATIONAL AERONAUTICS AND SPACE ADMINISTRATION
Lewis Research Center

Issued: October 19, 1964

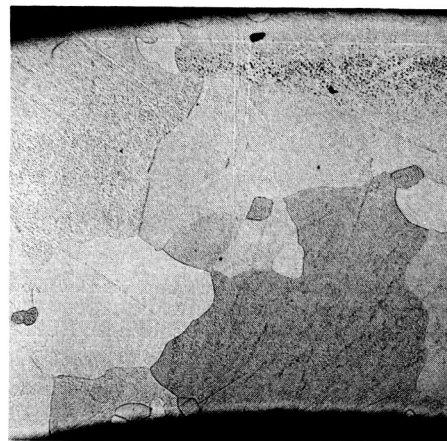
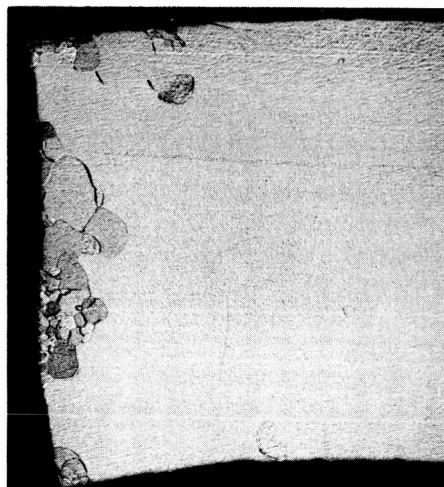
Fig. 13--Effect of thermal treatment on tungsten extruded at 1200°C
(6 in. to 12 in. sections)--Tube No. 13

Tubes 13, 14, and 15. These tubes were three 6-in. pieces cut from one 18-in. tube extruded at 1200°C. The only difference observed in the structure was that Tube 15 (last portion to be extruded) showed massive grain growth at a lower heat-treatment temperature (1800°C) than Tubes 13 and 14 (2000° to 2200°C).
